CONSTANT SYNOPTIC LANDSLIDE FROM LUHORE TO BUHOZI BUHOZI IN
KABARE TERRITORY NEAR BUKAVU/RDC

1. BACKGROUND

During the week of February 19 to 25, 2024, several alerts, through reports and images on the media and social networks, were issued on major ground deformations observed in Luhore, village of Buhozi (geographical coordinates: 2°33'15,52"S ;28°52'38,52"E).

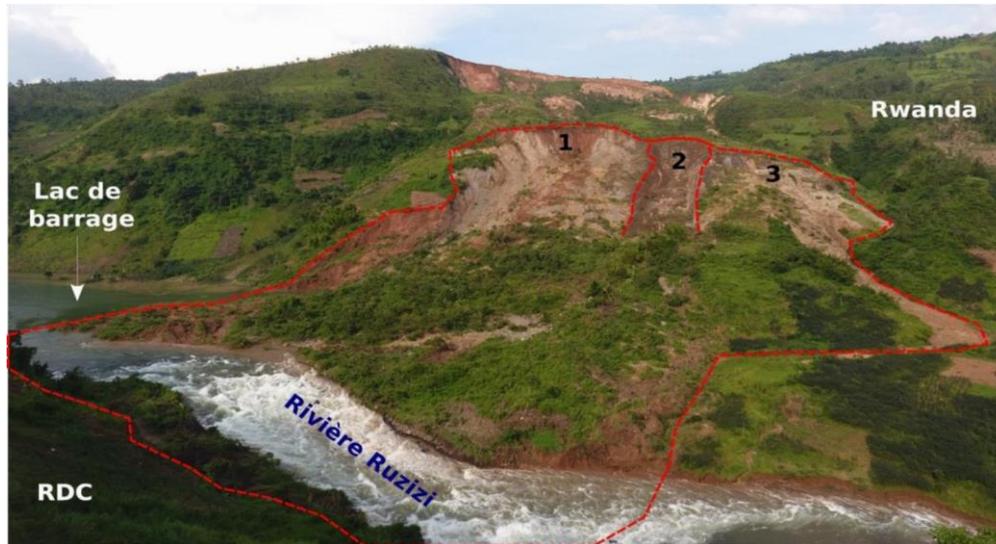
Observations from Lukula (DRC) show that the activity was deep-seated and occurred in several phases, with three major phases as indicated by the three source zones at the main escarpment (Figure 1). Two source zones (1 and 3) are associated with a flowslide-type process, and the third (2) with a flow-type process.

On the evening of February 24, 2024, the accumulation zone of the displaced mass was incised by the waters of the Ruzizi River, leaving part of it on the other bank of the river on the Congolese side (Figure 1). The part of the landslide on the Rwandan side still retains part of the dam lake created by the landslide activity.

Figure 1. Activity in an old landslide in the Ruzizi on the Rwandan side. The red dashed lines represent the area that moved on February 23, 2013. The various source zones and the remaining part of the dam lake are indicated.

- Regularly monitor the activity of the Ruzizi landslide near Lukula and the level of the dam lake. This dam lake poses a major risk when filled with water in the event of a new dam on the river, and may suddenly give way. The Ruzizi II hydroelectric power station and rural centers such as Kamanyola are under constant threat. With a lack of warning systems, this can cause a lot of damage downstream.

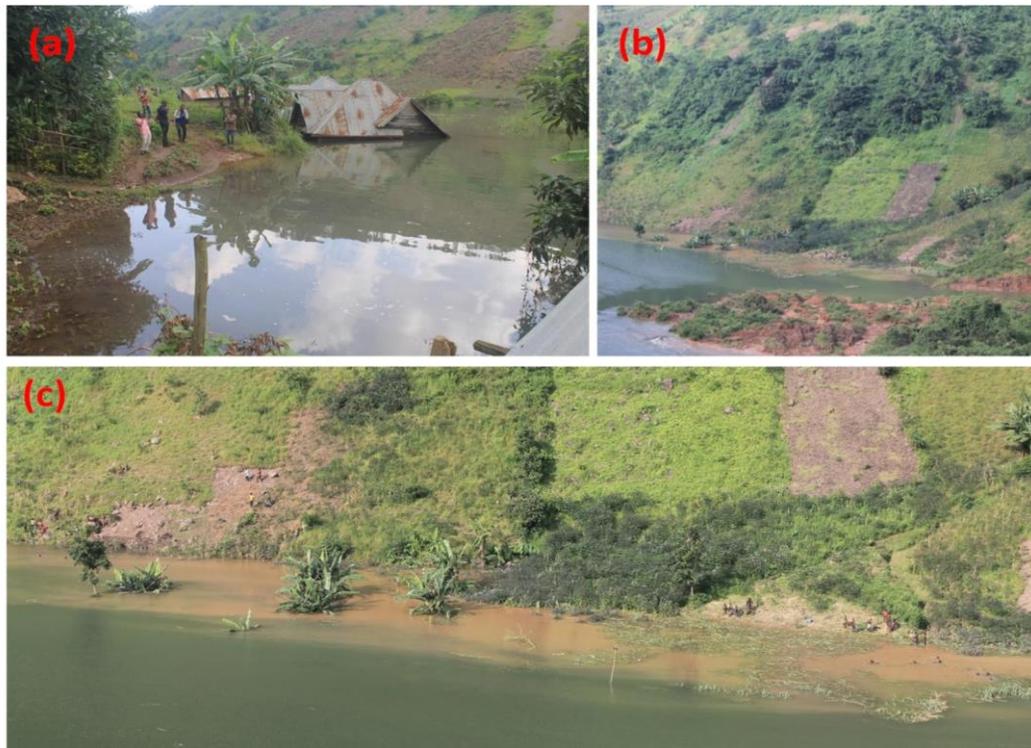
The landslide activity of February 23, 2024 created a dam lake on the Ruzizi River, causing flooding upstream and a gradual reduction in water levels downstream, particularly at the Ruzizi II hydroelectric power station (Figure 2). The flooded area covers 18 ha, 96% of which is agricultural land and 4% inhabited (Figure 2). A large proportion of the flooded fields and houses were still under water on February 24, 2024 (11am), but the water level had already fallen by 1m.

Figure 2: Flooding created by the dammed lake following landslide reactivation. (a) Flooded house (2.5439 South; 28.8736 East) upstream of the formed lake. (B and C) Flooded crops (2.5592 South; 28.8924 East) just at the point of dam lake formation.

- Provide humanitarian assistance in the form of essential materials and foodstuffs.
- Organize, in a coordinated and urgent manner, the relocation of the population from the area affected by the Luhore landslide to the Kamagema river. Part of the population has already taken the initiative to evacuate, but seems to have been left to its own devices. There is an urgent need to identify and prepare a relocation site outside the unstable zone, and to move the threatened population to this site. The area affected by the landslide must be formally forbidden to build new houses, even after a period of instability.
